iowa valley elementary scorecard breakdown

iowa valley elementary interior analysis

iowa valley elementary flooring analysis

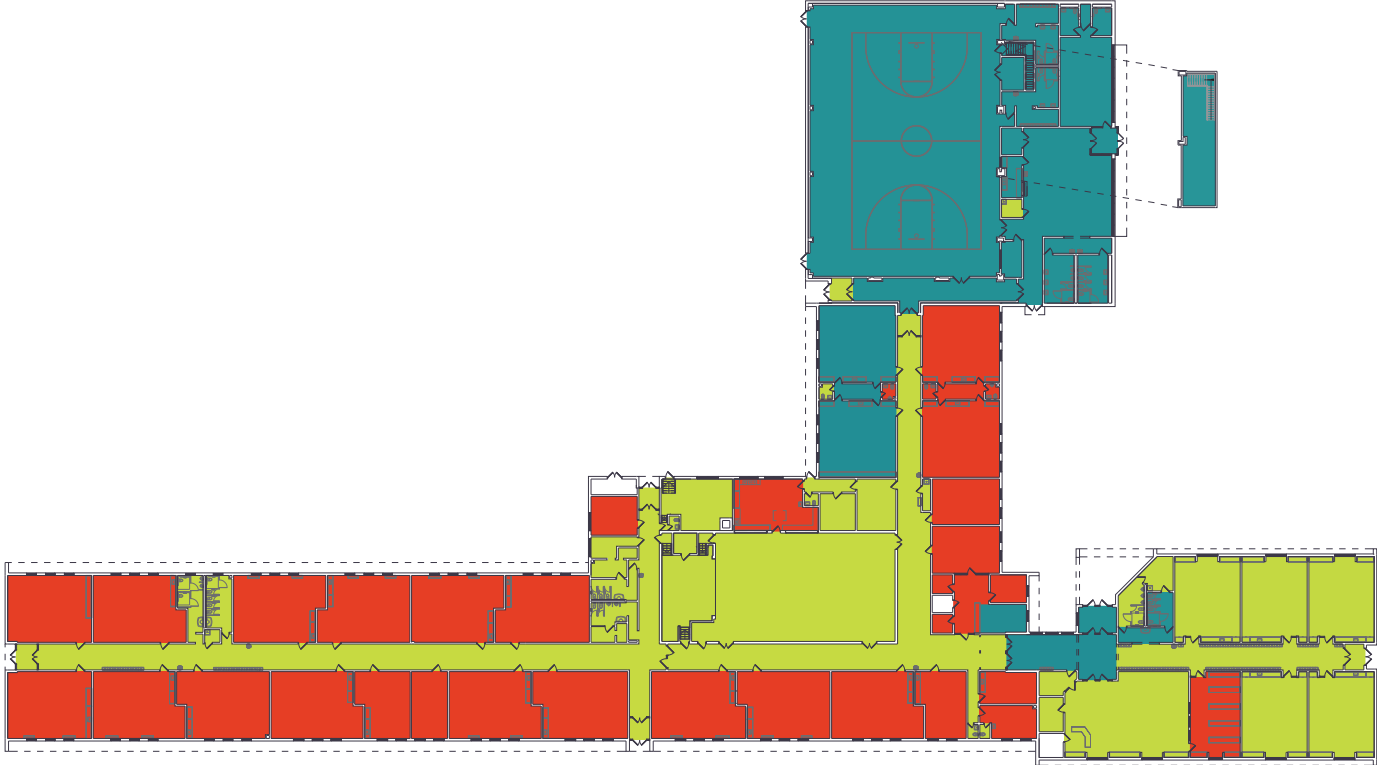
First Floor

- The flooring in the classrooms in the north wing of the building is in poor condition due to containing potential asbestos tile.
- Majority of the terrazzo flooring in the corridors appears to be in fair condition.
- Majority of the flooring in the 2016 gym addition appears to be in good condition.
